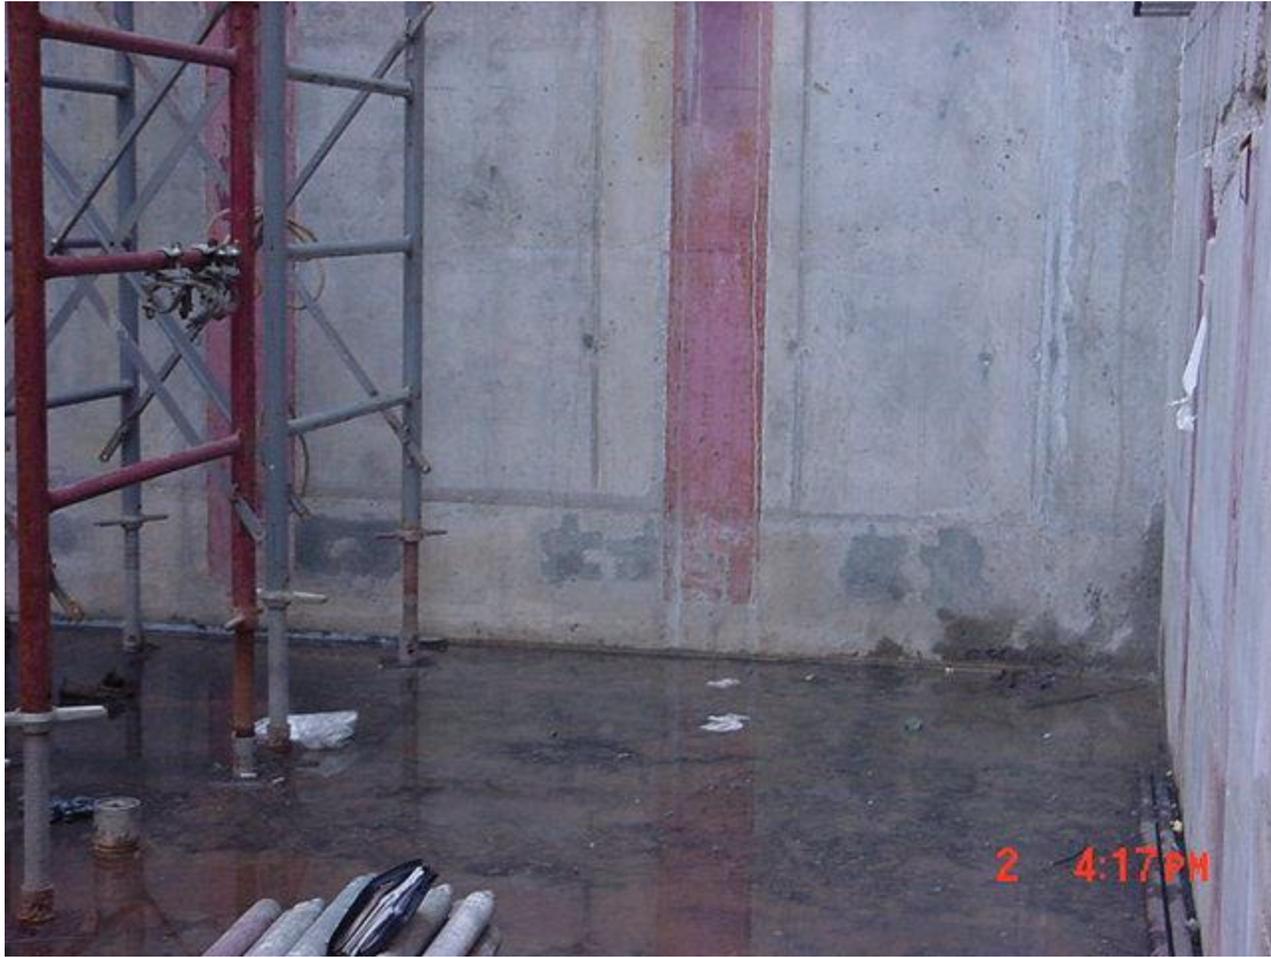
This is a picture of the actual accident site. The shoring end frames with the leveling screws jacks are extended to level the shoring. The distance from the shoring end frame to the wall is approximately 8 feet.

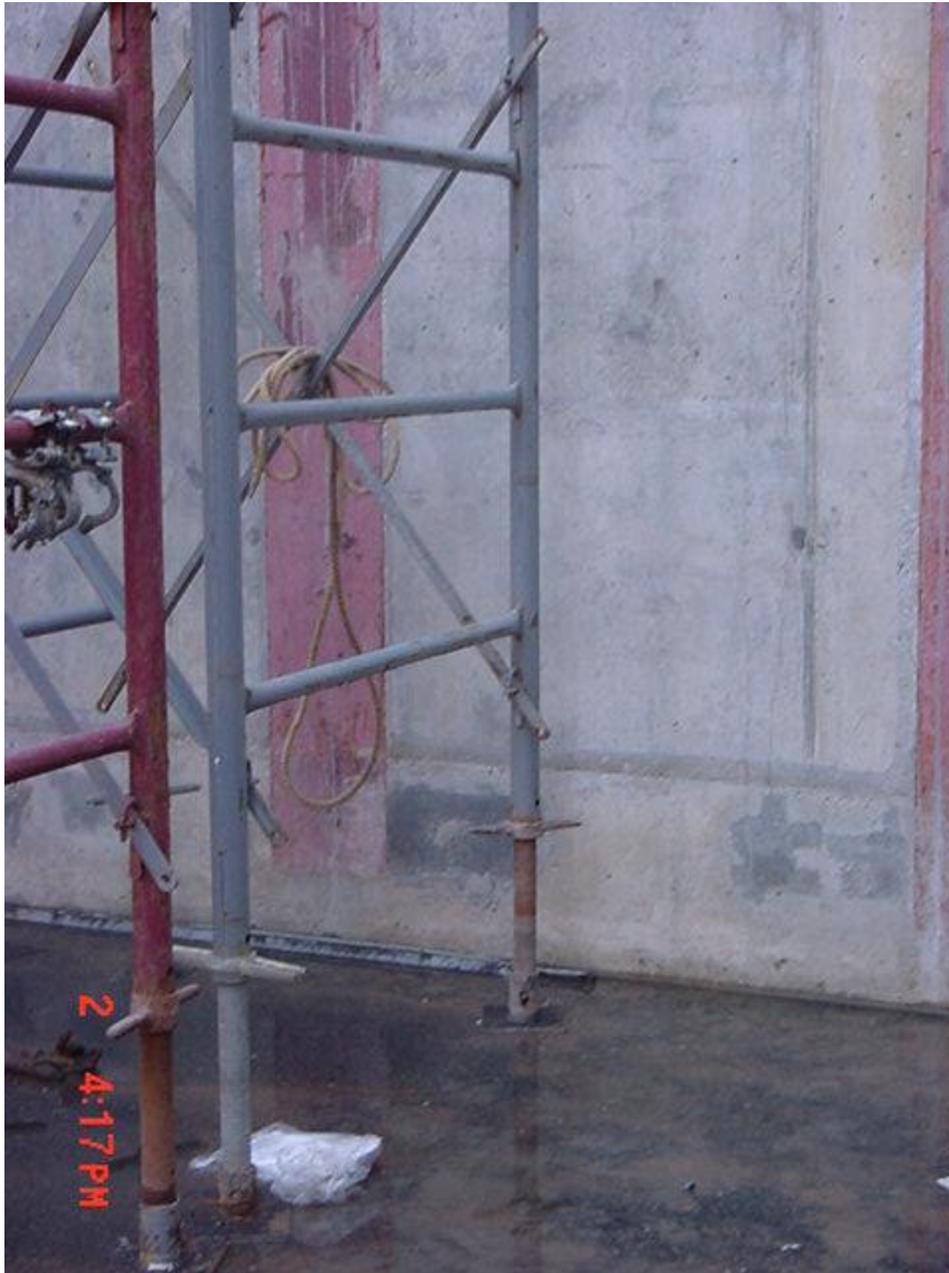
Close-up view of the shoring with the leveling screws jacks extended.

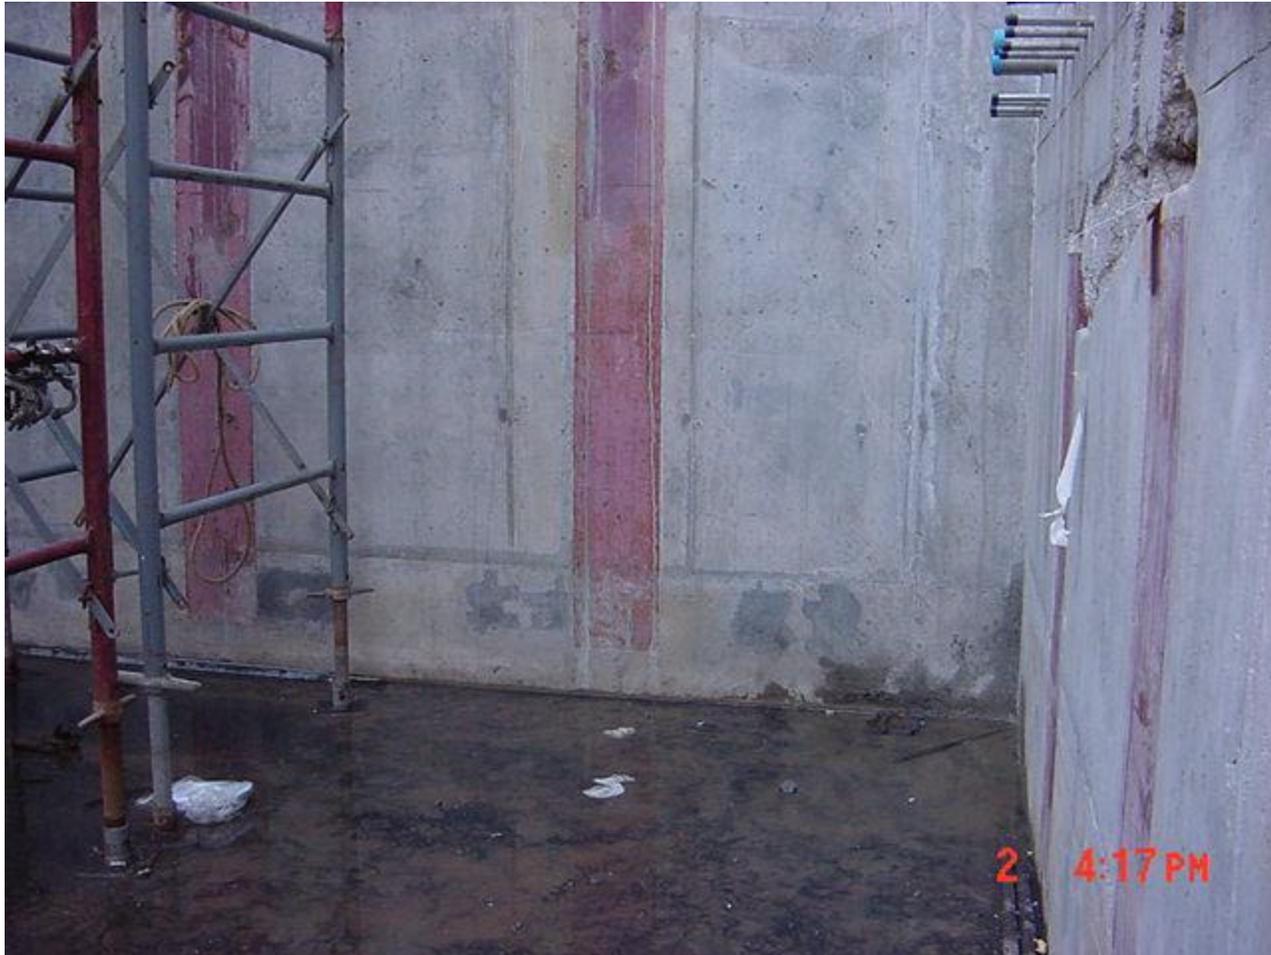
The floor in this area is wet with approximately a quarter inch of water.

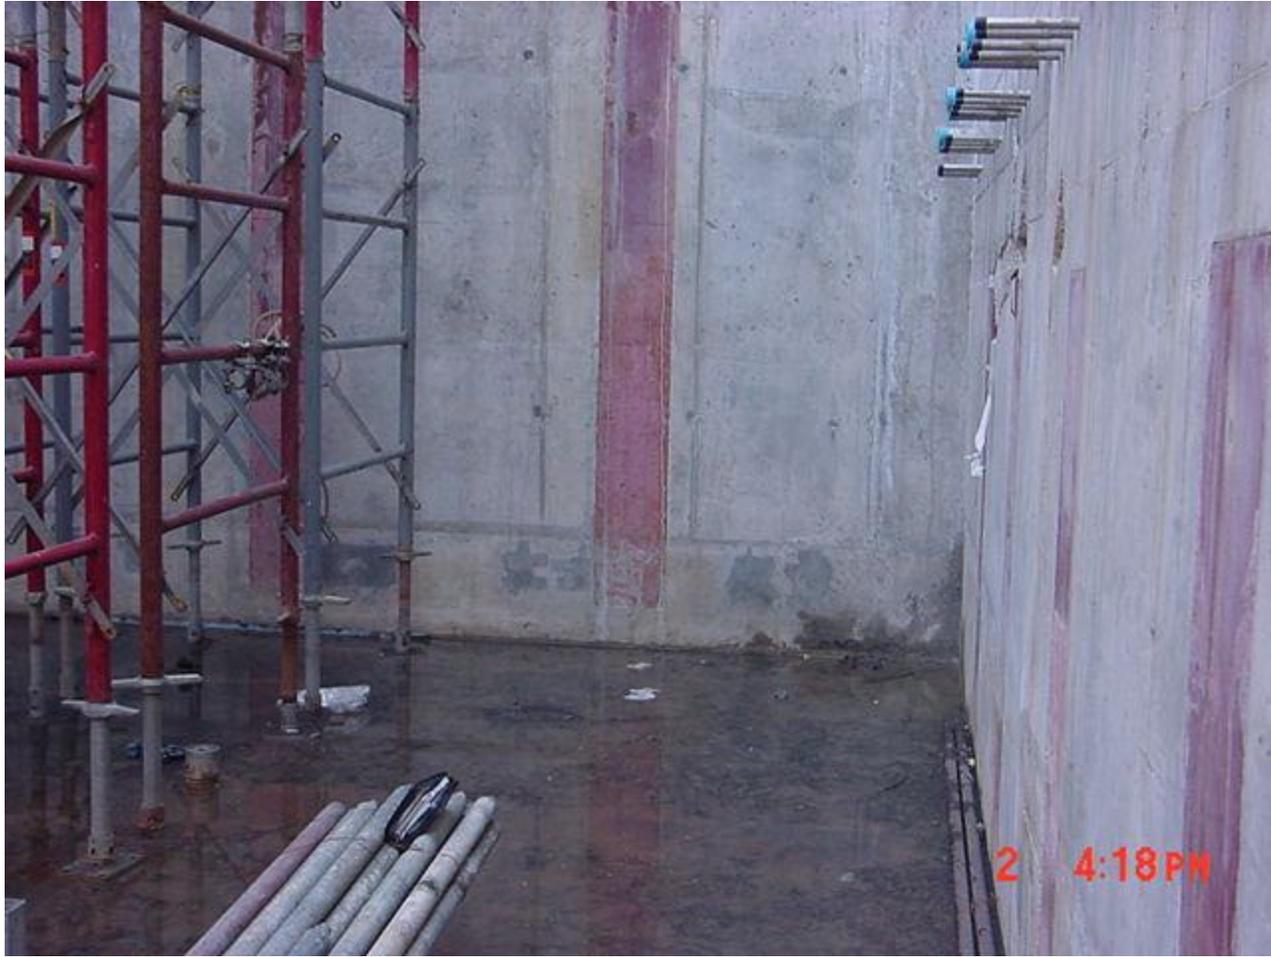
Another view of the wet floor and shoring.

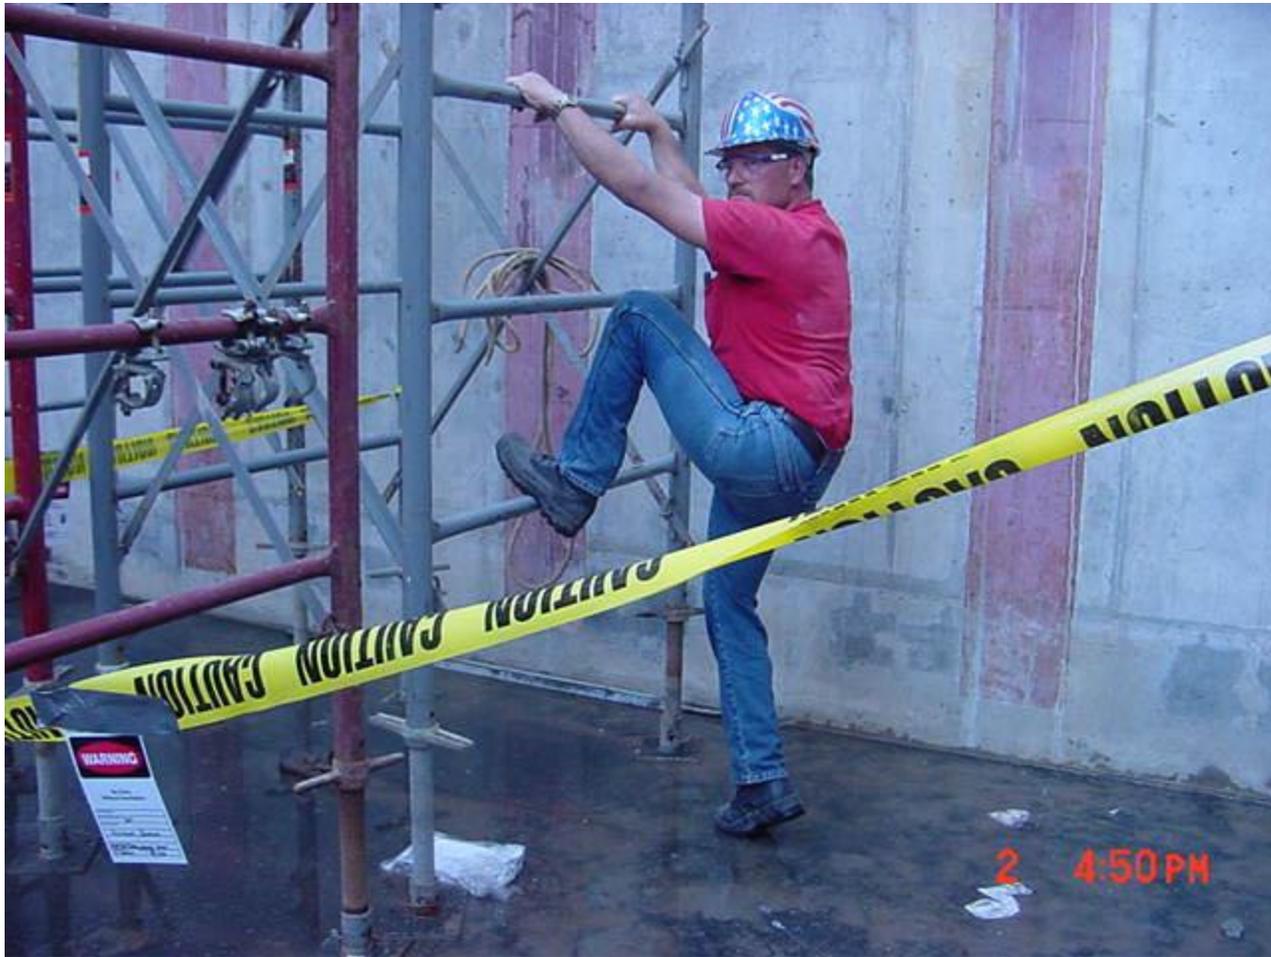
This is a re-enactment of the injury -- this employee was a witness to the accident

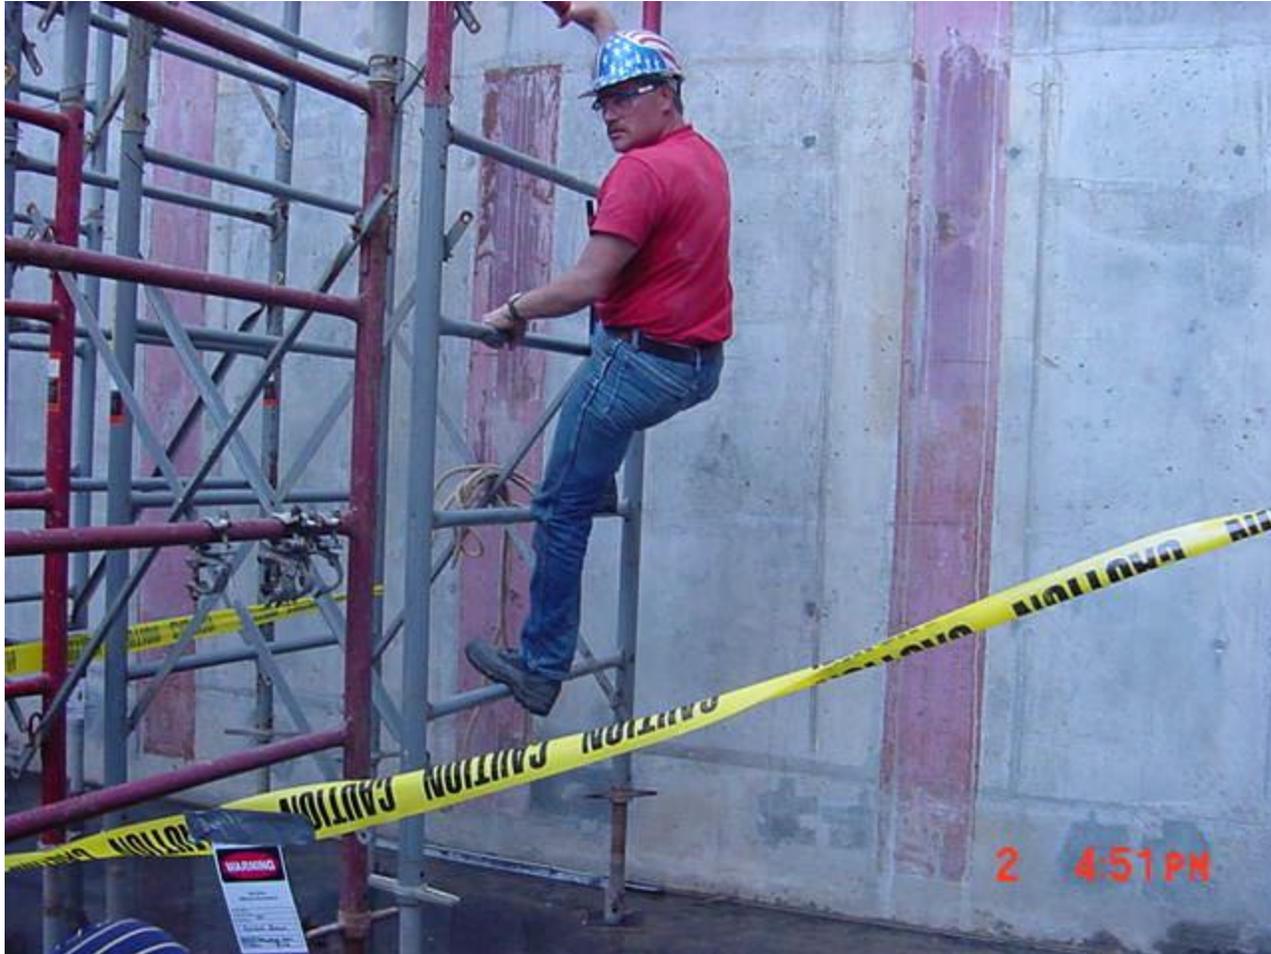
This picture shows the re-enactment position of the employee that fell. It is presumed that as the employee slipped and lost his balance, he struck the floor with his feet, and then stumbled backwards and hit the wall with his head.
