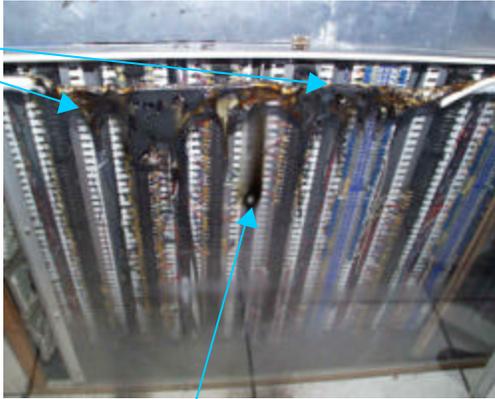
Note  
blackened  
and  
melted  
plastic  
along  
top.

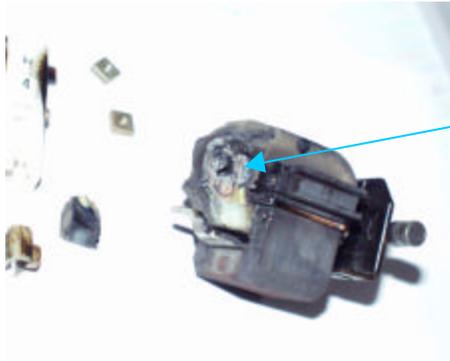
Location of relay with cover removed.

Internal examination of the relay components shows temperature-related discoloration of the coil. This indicates temperatures over 1400 F. Molten metal indicates electrical arcing. Sparks were likely.
